UNDERWATER BRIDGE INSPECTION REPORT

STRUCTURE NO. 69623

ST. LOUIS RIVER

MINNESOTA DEPARTMENT OF TRANSPORTATION
UNDERWATER BRIDGE INSPECTION

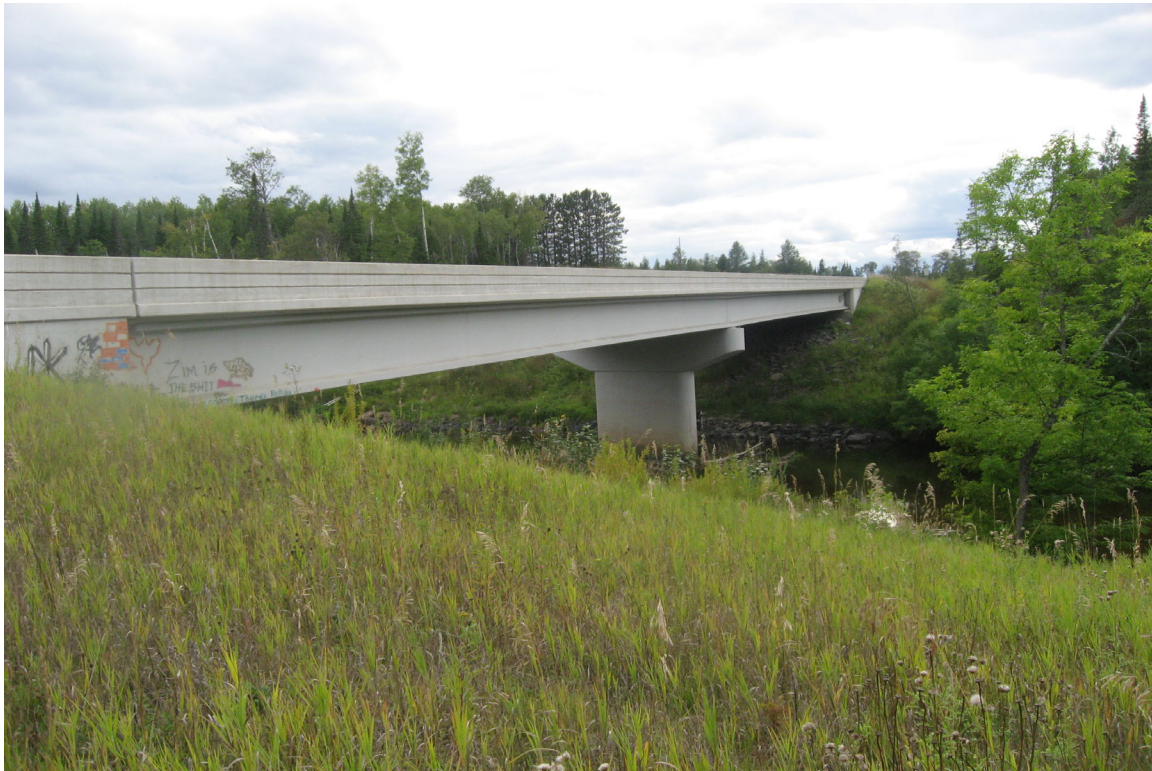
Photograph 1. Overall View of Structure, Looking Southwest.

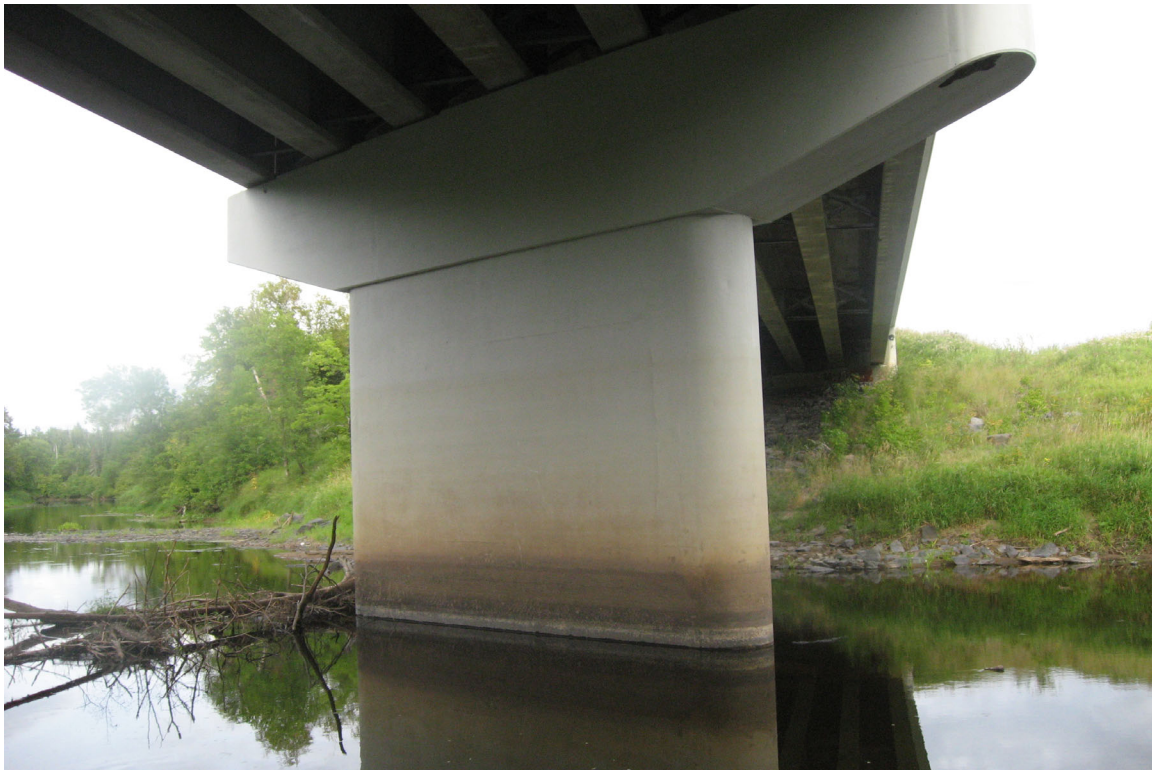
- (A) The concrete of Pier 1 was smooth and sound with no notable deterioration.
- (B) A heavy accumulation of timber debris was observed at the upstream nose of Pier 1. The accumulation extended approximately 30 feet into the channel, and from about 20 feet upstream of the nose to halfway down the east side of the pier, with a 2-foot-diameter log extending along the west side of the pier.
- (C) A band of light scaling was observed around the entire perimeter of Pier 1 extending from the waterline to 1.5 feet above the waterline, with 1/8 inch maximum penetrations.

Photograph 2. View of Pier 1 and Drift Accumulation, Looking Northeast.

- (A) Remove the heavy accumulation of timber debris at the upstream nose and along the side of Pier 1 to alleviate scour influence at the pier and any further accumulation.

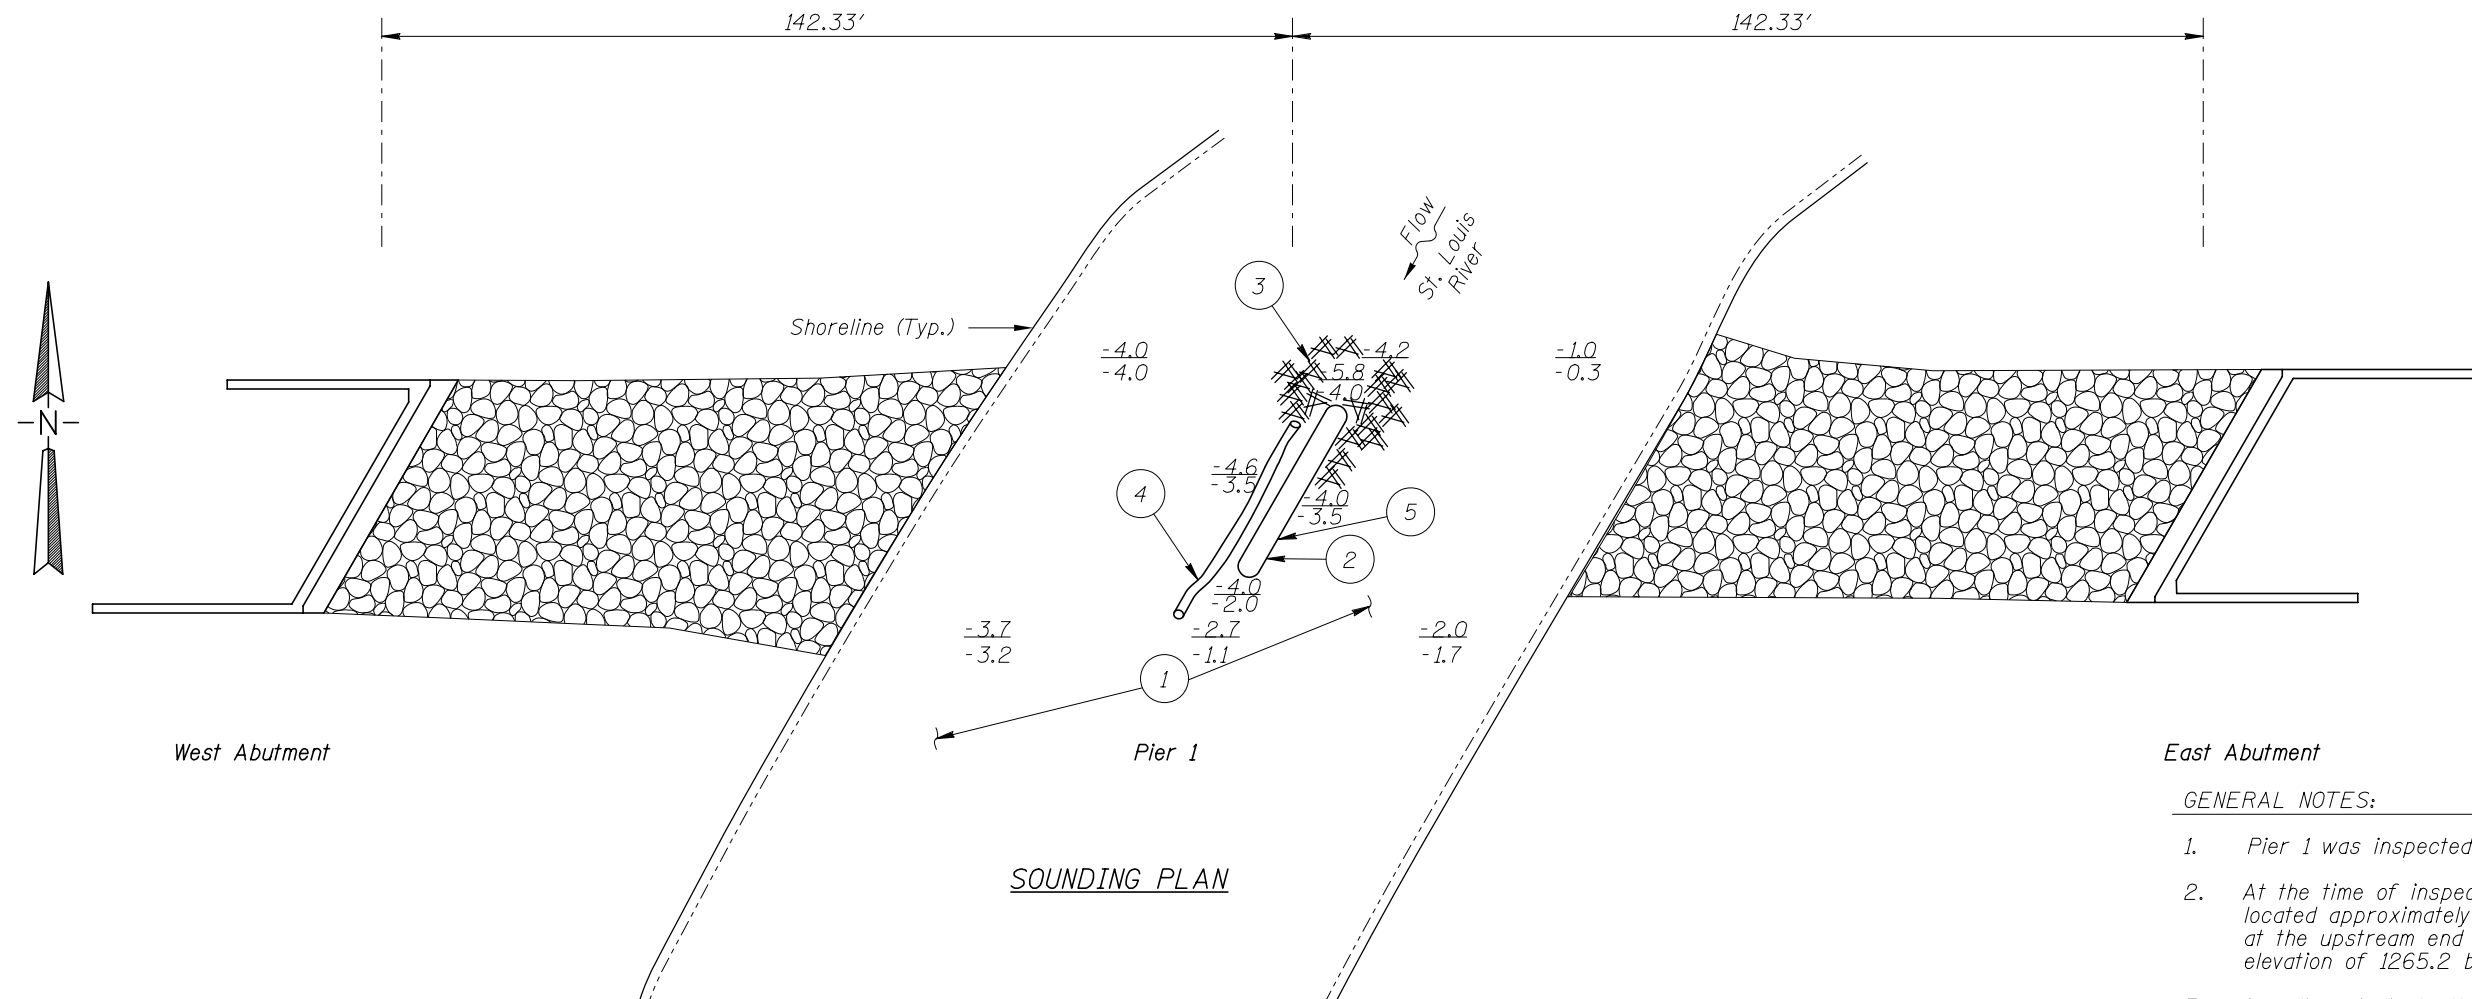
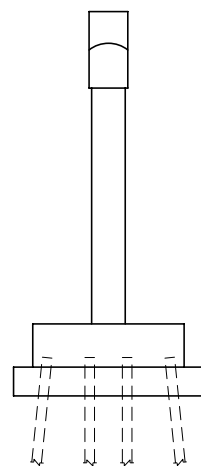
INSPECTION AND SOUNDING PLAN

- The channel bottom consisted of soft silt with 1.5 to 2 feet of probe rod penetration and riprap at the upstream nose of Pier 1.
- The concrete of Pier 1 was smooth and sound.
- A heavy accumulation of timber debris was observed at the upstream nose of Pier 1 extending from the channel bottom to 6 feet above the waterline. The accumulation extended approximately 30 feet into the channel and from about 20 feet upstream of the nose to halfway down the east side of the pier, with a 2-foot-diameter log extending along the west side of the pier.
- A 2-foot-diameter log was observed along the west side of Pier 1.
- Light scaling was observed around entire pier from waterline to 1.5 feet above the waterline with 1/8 inch max penetration.
